CANFARMSAFE™

004-1-1

Testing the New Swine Transport Trailer Part 1 - Road Tests

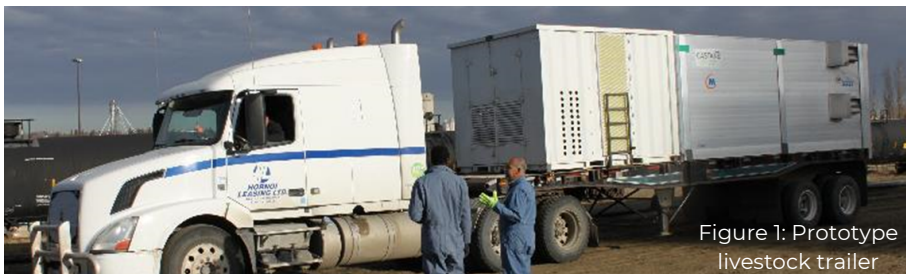
Figure 1: Prototype livestock trailer

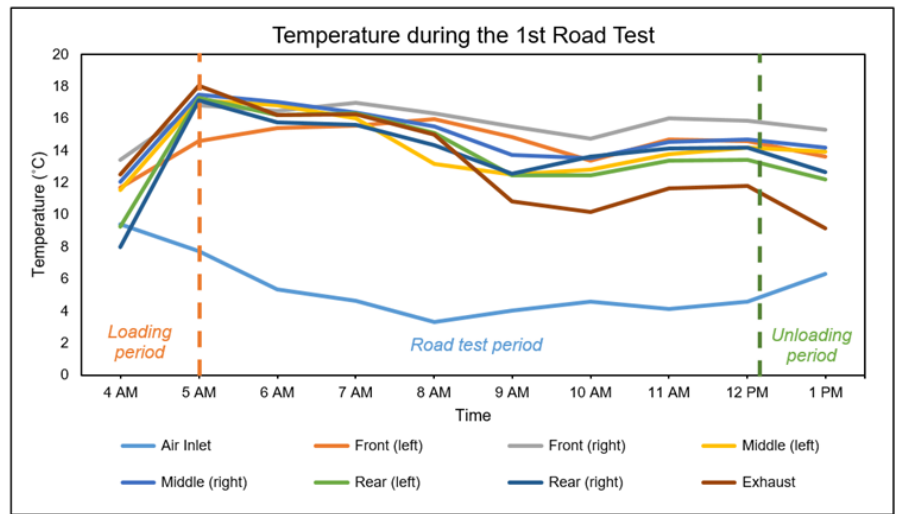
Figure 4: Trailer temperature time series

As shown in Figures 4 and 5, the target environmental conditions were maintained in the animal compartment even with the large difference in recorded temperature between air inlet and animal compartment. It should be noted that the temperature in the front, middle, and rear compartment all followed the same trend, indicating that the spatial factor was insignificant and that the installed fans, heaters, and wall insulation were working as expected. However, a slight drop in exhaust air temperature was observed between 8 to 11 a.m. This was attributed to extreme gustiness of wind blowing against the exhaust. The recorded drop in temperature during the unloading period was due to opening of the back door, allowing cold outside air to enter the animal compartment.

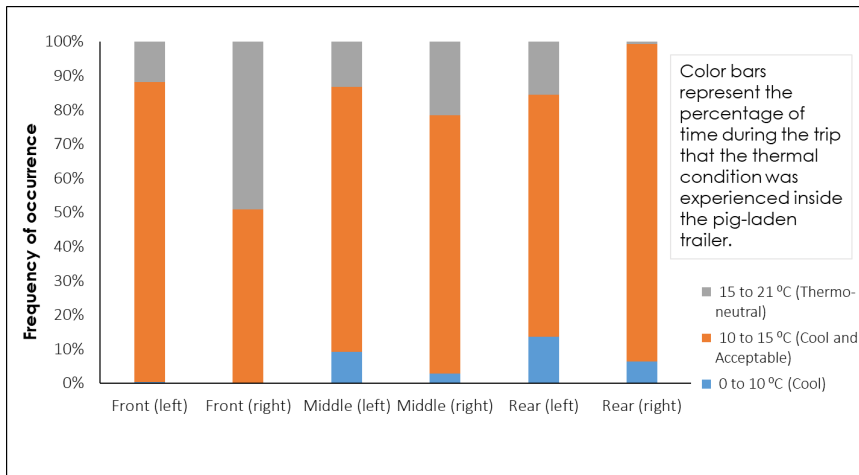
Figure 5: Thermal comfort classification
